Special Protection Area Program Annual Report 2006

Prepared by the Montgomery County Department of Environmental Protection in Cooperation With the Department of Permitting Services and the Maryland-National Capital Park and Planning Commission

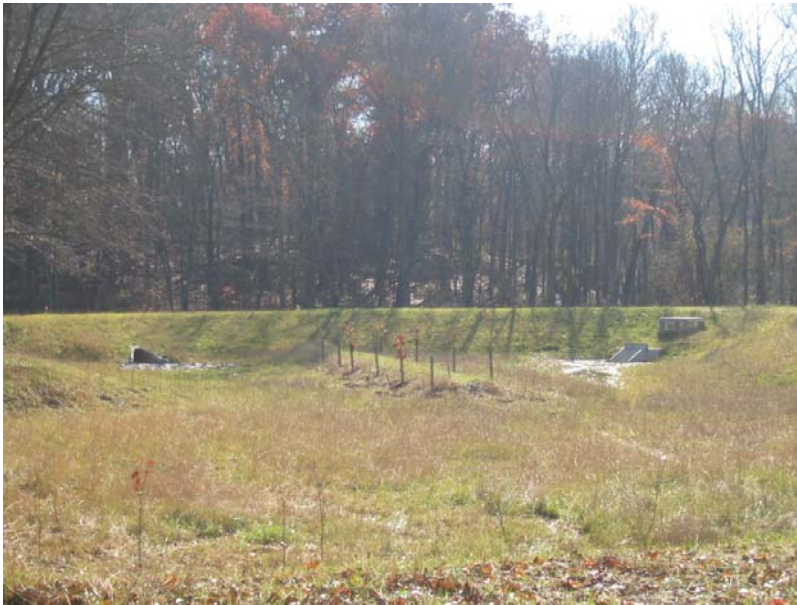
Figure 19. Gum Springs Stormwater Management Pond

The new Gum Springs stormwater management pond and buffer reforestation project completed in 2006 controls 122 acres that previously had no stormwater management (Figure 19). The pond is near the intersection of Sturtevant Road and Ansted Road. The area controlled is 18 percent of the drainage area of Gum Springs at that point. The pond will greatly reduce peak flows from most small frequently occurring storms. Larger less frequent storms that only occur on average every six months will have their peak flow rates attenuated by 70 percent. Even larger storms that on average only occur once a year will have their peak flow rates reduced by 44 percent. This change in runoff patterns should have a beneficial effect on Gum Springs by reducing stream bank erosion and in-stream sediment loads. Over 1.3 acres of stream buffer area were reforested in association with construction of the pond which should also contribute to improved water quality conditions in Gum Springs.
